CONSERVATION *Showcase*

Program helps restore hydrology, wetlands, cultural resources on Yakama lands

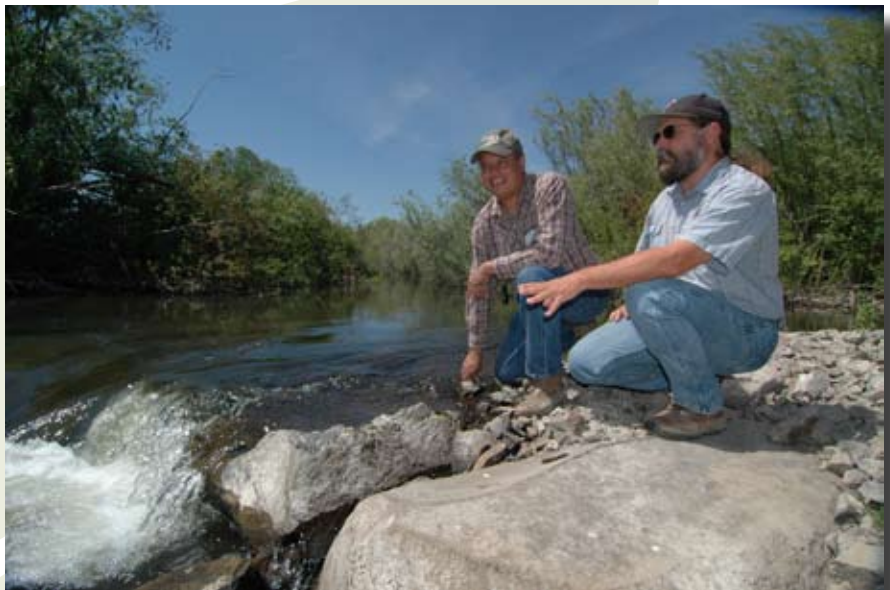
Tribal Wildlife Biologist Tracy Hames, right, and NRCS Tribal Liaison Roger Amerman, pause near one of the 28 engineered grade control structures that have helped restore the natural hydrology to Mid-Toppenish Creek.

Through NRCS' program, the Tribe has installed 28, man-made grade control structures to lift the base level of the creek up several feet, in order to allow the beavers to begin restoring it again and to allow the floods to perform their hydrologic role.

"They look like real simple structures, but there's a lot of engineering in them," Mr. Hames says standing atop a row of the columnar basalt rocks, which comprise the structure and stretch across

the stream. "The rock is taken from a place here on the reservation and the structures are engineered such that they form and inverted 'V' so the point of the 'V' faces upstream, forcing the flow toward the middle of the stream to reduce bank erosion. They also act like natural cascades, making it much easier for the

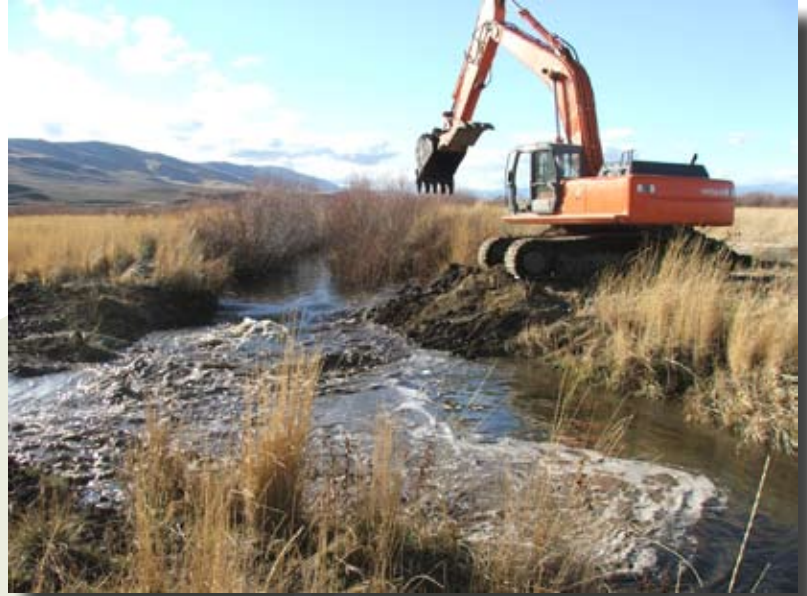
With the grade control structures in place, a backhoe operator breaches a temporary de-watering dam, allowing water from Mid-Toppenish Creek to flow along its historic channel. (Photo courtesy Tracy Hames.)
